Semiannual Progress Report  
Determination of the Emissivity of Materials  
Contract NAS3-4174

Report Period: November 15, 1965 through May 14, 1966

Technical Management: National Aeronautics and  
Space Administration, Lewis Research Center  
Space Power Systems Division  
R. L. Davies and J. A. Milko

The testing of coatings applied to AISI-310 stainless steel and columbium-1 percent zirconium was continued during the report period. In addition, the study of the adherence, compatibility, and emittance of coatings applied to beryllium was completed.

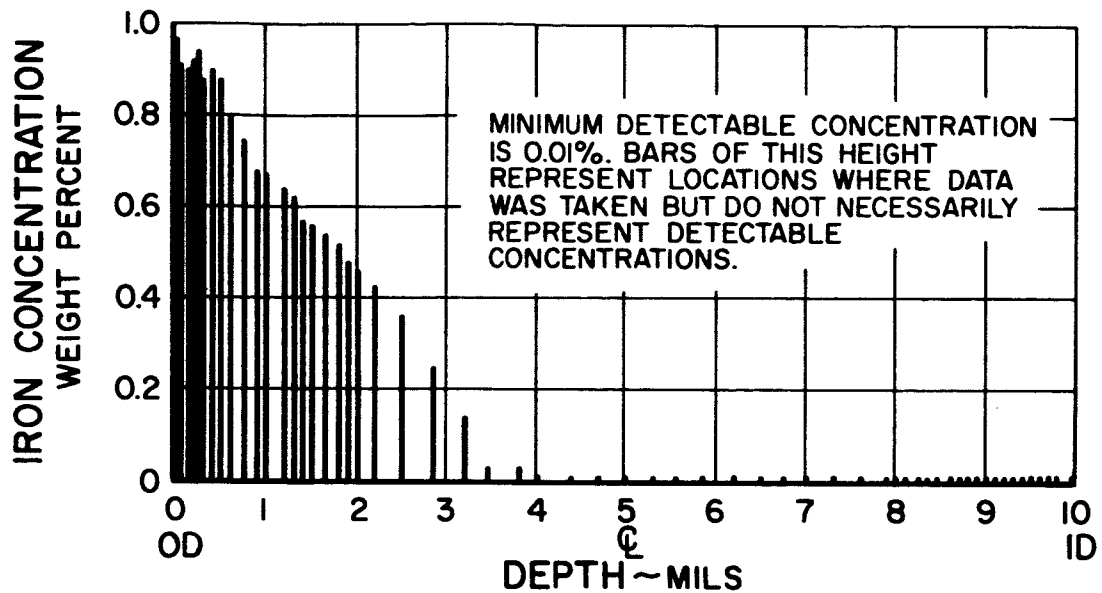
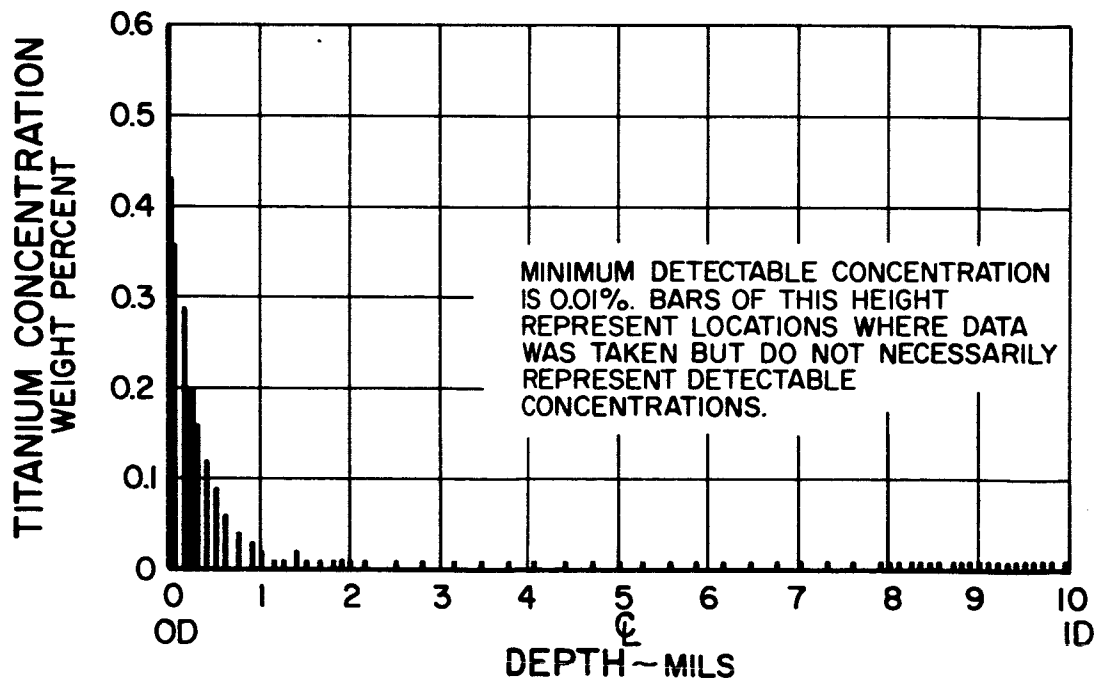
Figure 21 Concentrations of Iron and Titanium Across Columbium-1 Percent Zirconium Tube Coated With Iron-Titanate and Endurance Tested at 1700°F for 10,000 Hours

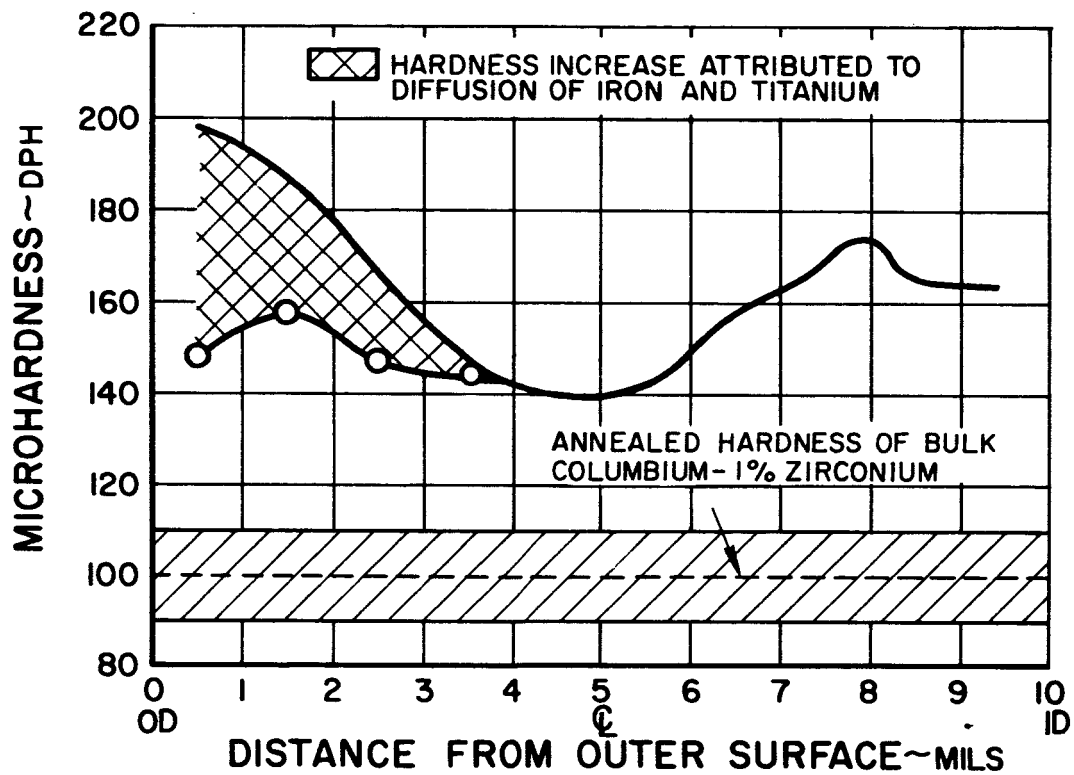
Figure 22 Effect of Iron and Titanium Diffusion on Hardness of Columbium-1 Percent Zirconium Tube Coated With Iron Titanate and Endurance Tested at 1700°F for 10,000 Hours

Investigations of the effects of iron and titanium on columbium alloys indicate that both of these constituents increase the alloy hardness through solid solution strengthening effects. Specifically, 1 weight percent of iron has been found<sup>5</sup> to increase the diamond pyramid hardness by 50 kg/mm<sup>2</sup> over the base hardness, and 1 weight percent of titanium increases the hardness by 40 kg/mm<sup>2</sup>. On the basis of the known concentrations of iron and titanium in the substrate, the corresponding increases in hardness were calculated for each mil of depth into the substrate for which detectable concentrations of these elements were found. Subtracting the values calculated from the average measured substrate hardness results in the lower curve shown in Figure 22. As shown, virtually all of the hardness gradient detected at the outer surface of the substrate can be accounted for by the solid solution hardening effects of the iron and titanium in this region.

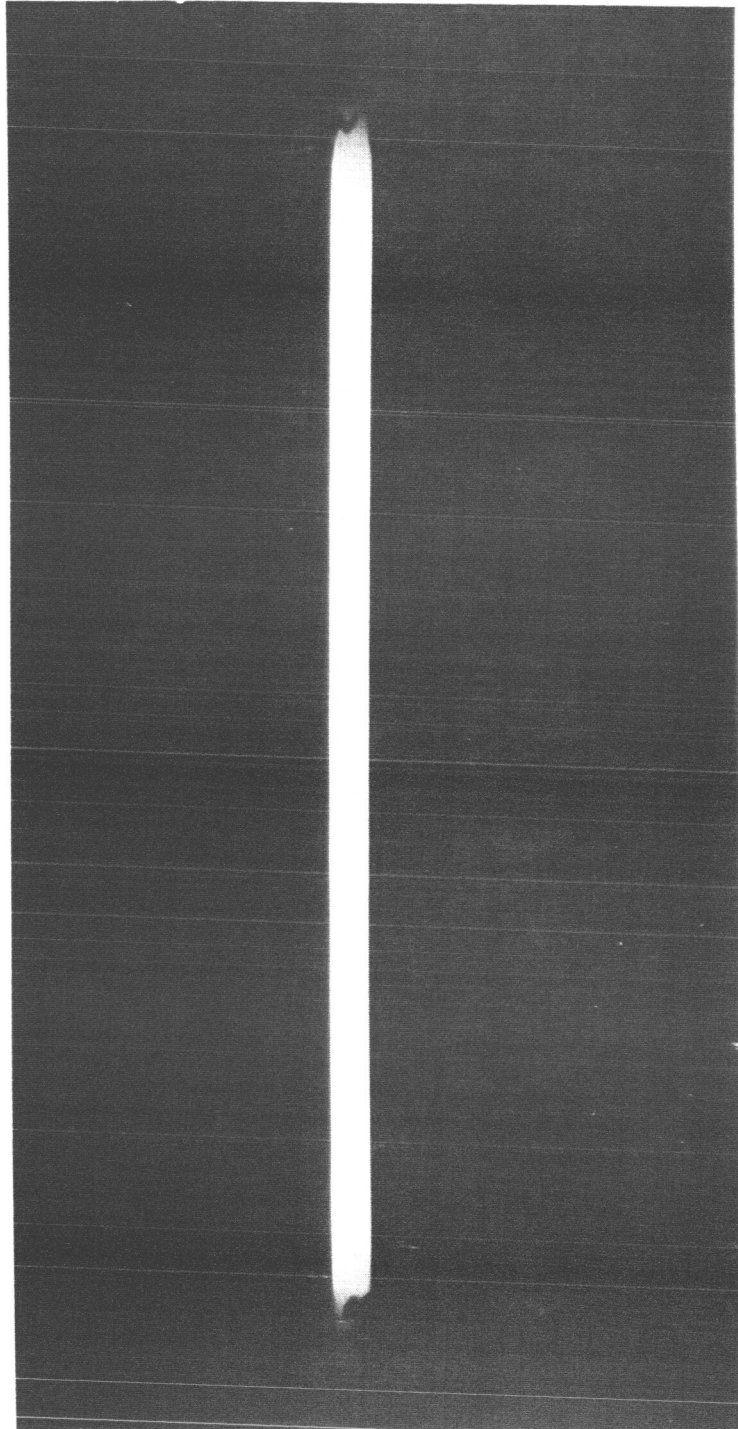
Figure 23 Aluminum-Oxide-Aluminum-Titanate-Coated Columbium-1 Percent Zirconium Tube at 1700°F in Vacuum Prior to Completion of 10,000 Hours of Testing

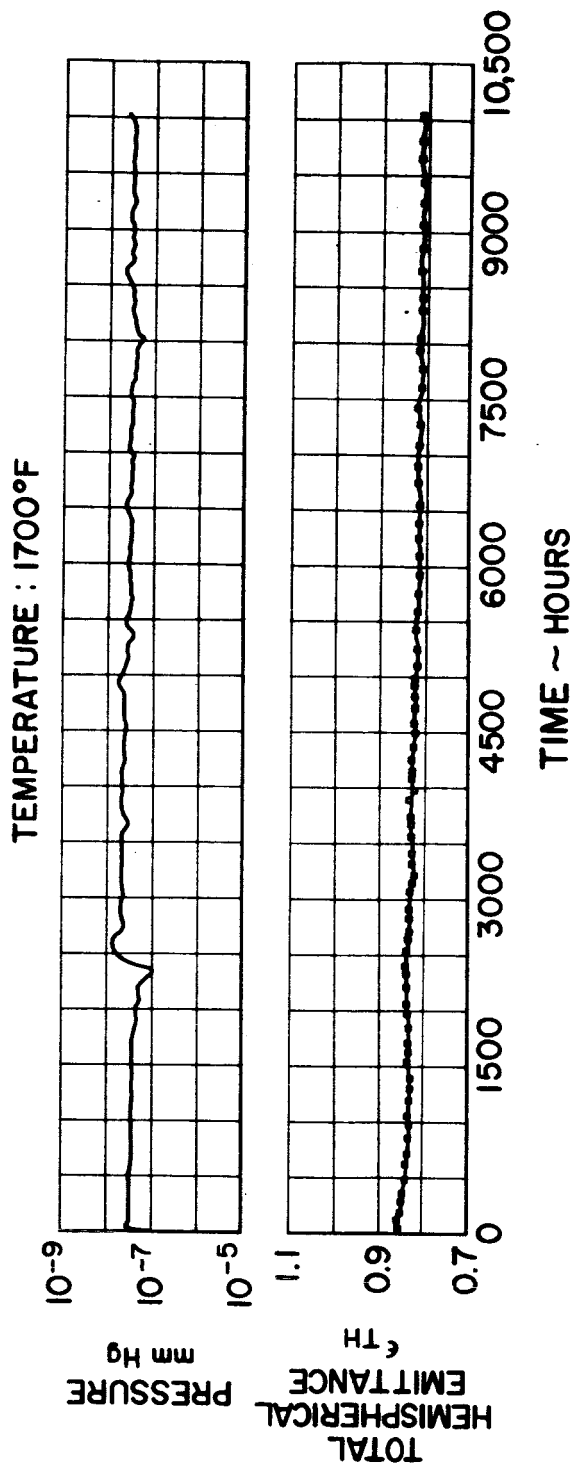
Figure 24 Pressure and Total Hemispherical Emittance for Long-Term Endurance Test of Aluminum-Oxide-Aluminum-Titanate-Coated Columbium-1 Percent Zirconium

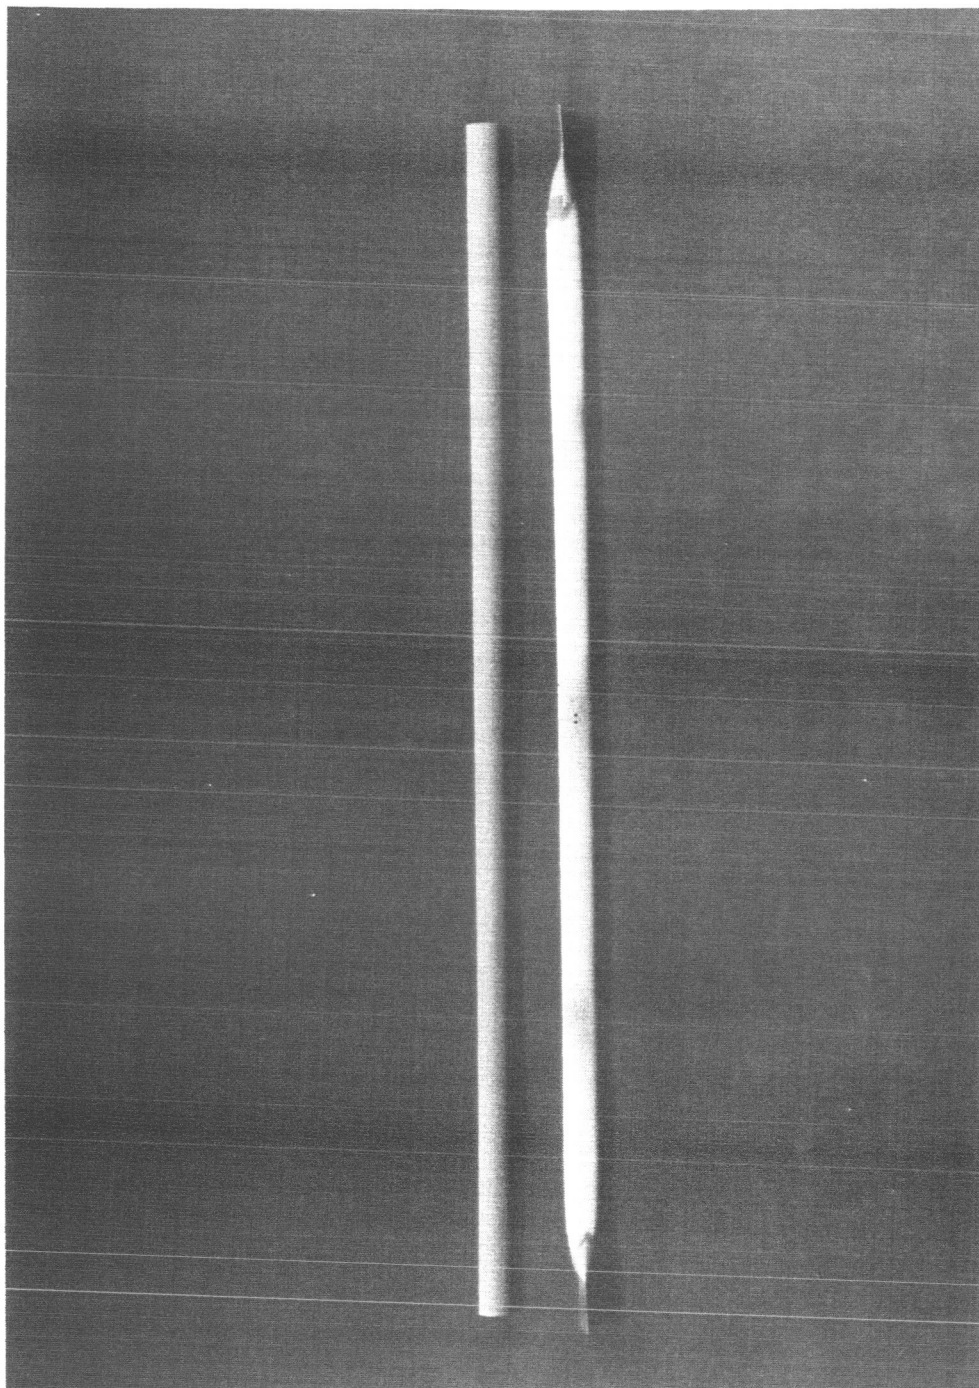
Figure 25 Appearance of Aluminum-Oxide-Aluminum-Titanate-Coated Columbium-1 Percent Zirconium Tube Before (Left) and After (Right) Testing  
XP-65742

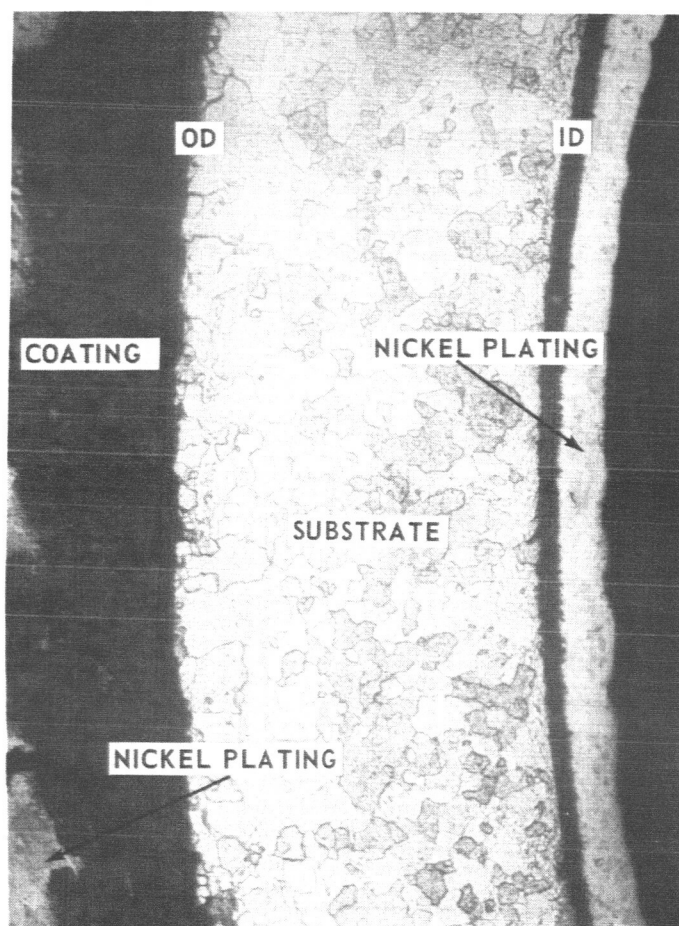
Figure 26 Cross Sectional Photomicrograph of Aluminum-Oxide-Aluminum-Titanate-Coated Columbium-1 Percent Zirconium Tube After Endurance Testing at 1700°F for 10,000 Hours

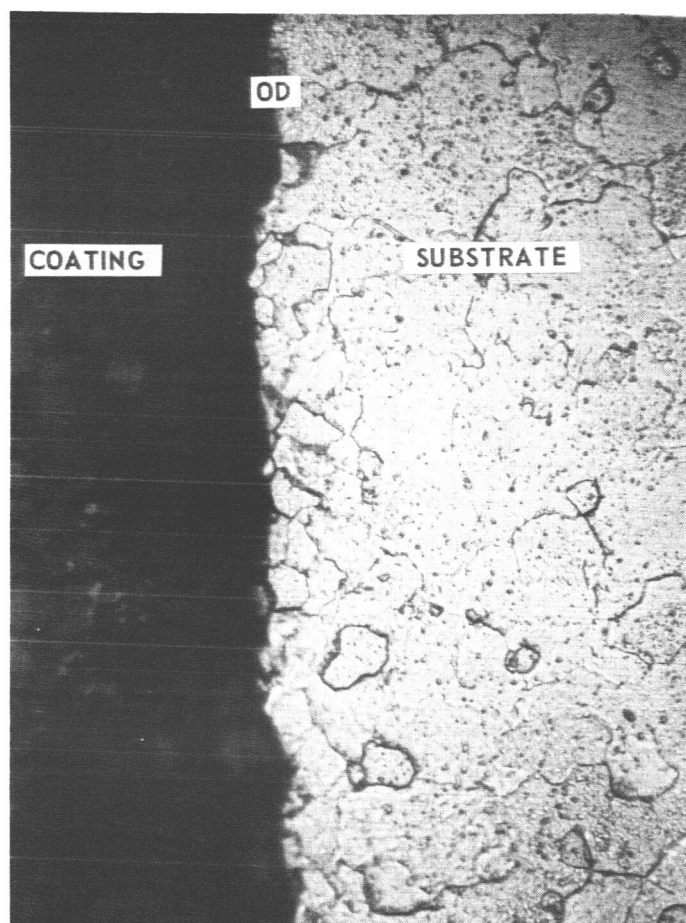
Figure 27 Cross Sectional Photomicrograph of Aluminum-Oxide-Aluminum-Titanate-Coated Columbium-1 Percent Zirconium Tube After Endurance Testing at 1700°F for 10,000 Hours

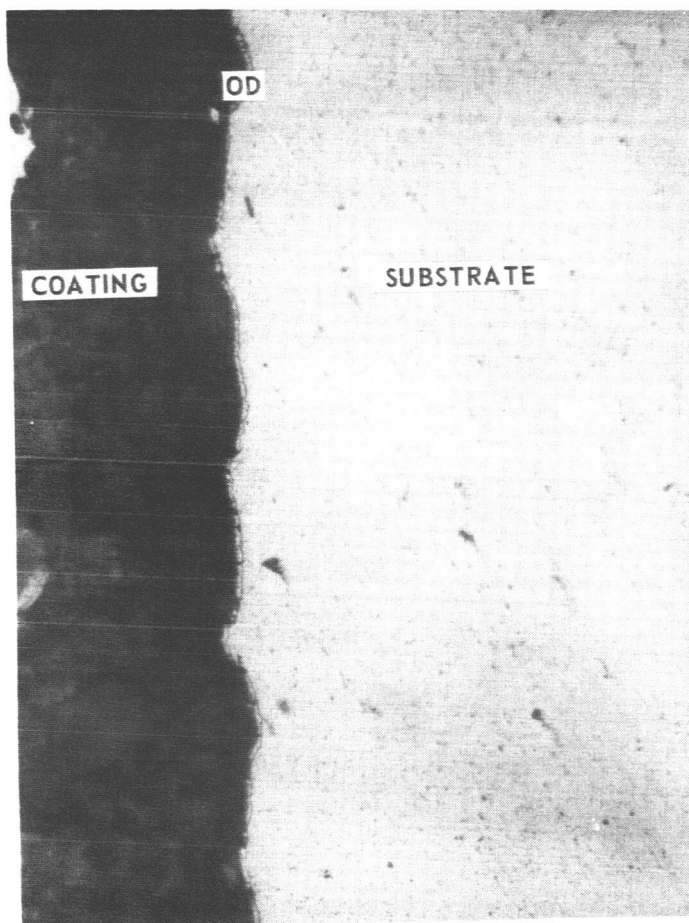
Figure 28 Cross Sectional Photomicrograph of Aluminum-Oxide-Aluminum-Titanate-Coated Columbium-1 Percent Zirconium Tube After Endurance Testing Etched to Show Second Phase at Coating-Substrate Interface

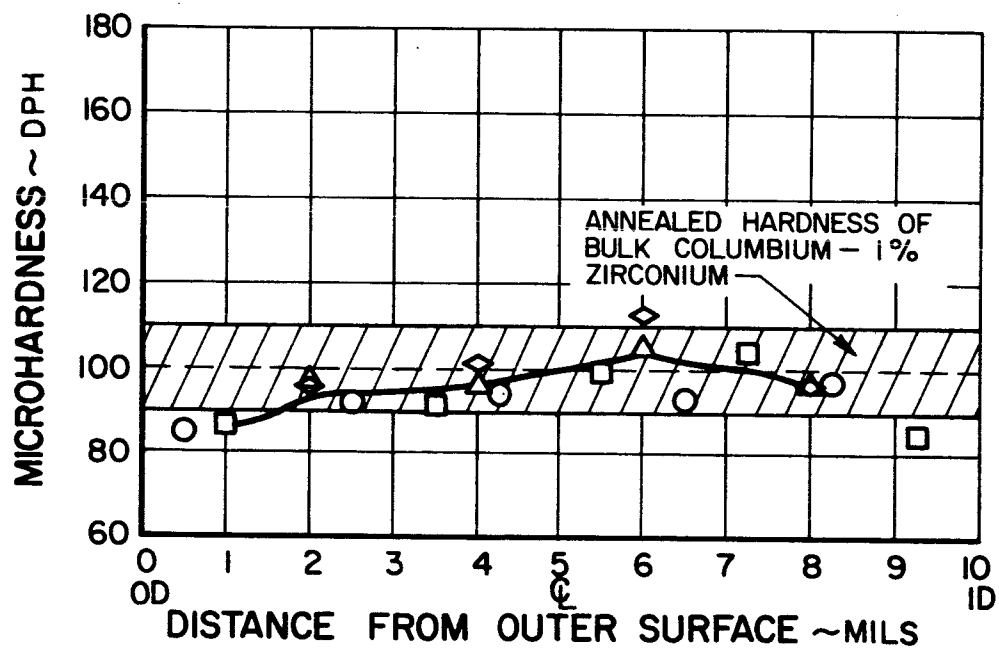
Figure 29 Microhardness Traverse Results for Endurance-Tested Columbium-1 Percent Zirconium Tube Coated With Aluminum-Oxide-Aluminum-Titanate

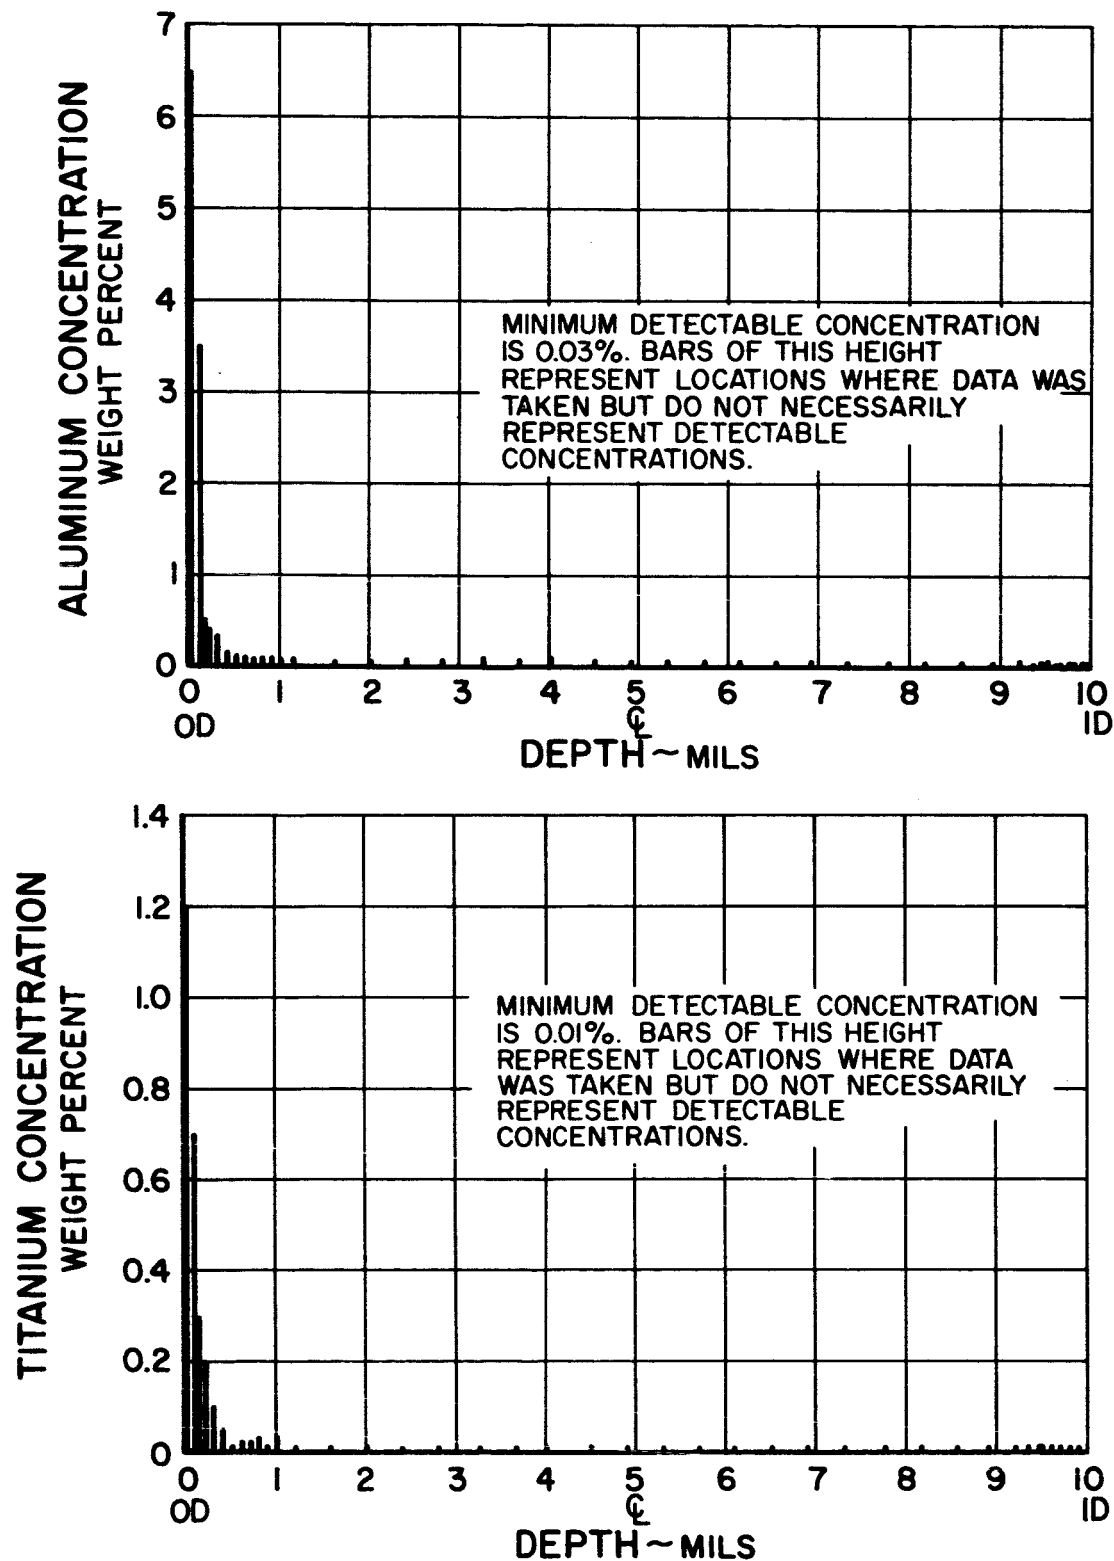
Figure 30 Concentrations of Aluminum and Titanium Across Columbium-1 Percent Zirconium Tube Coated With Aluminum-Oxide-Aluminum-Titanate and Endurance Tested at 1700°F for 10,000 Hours

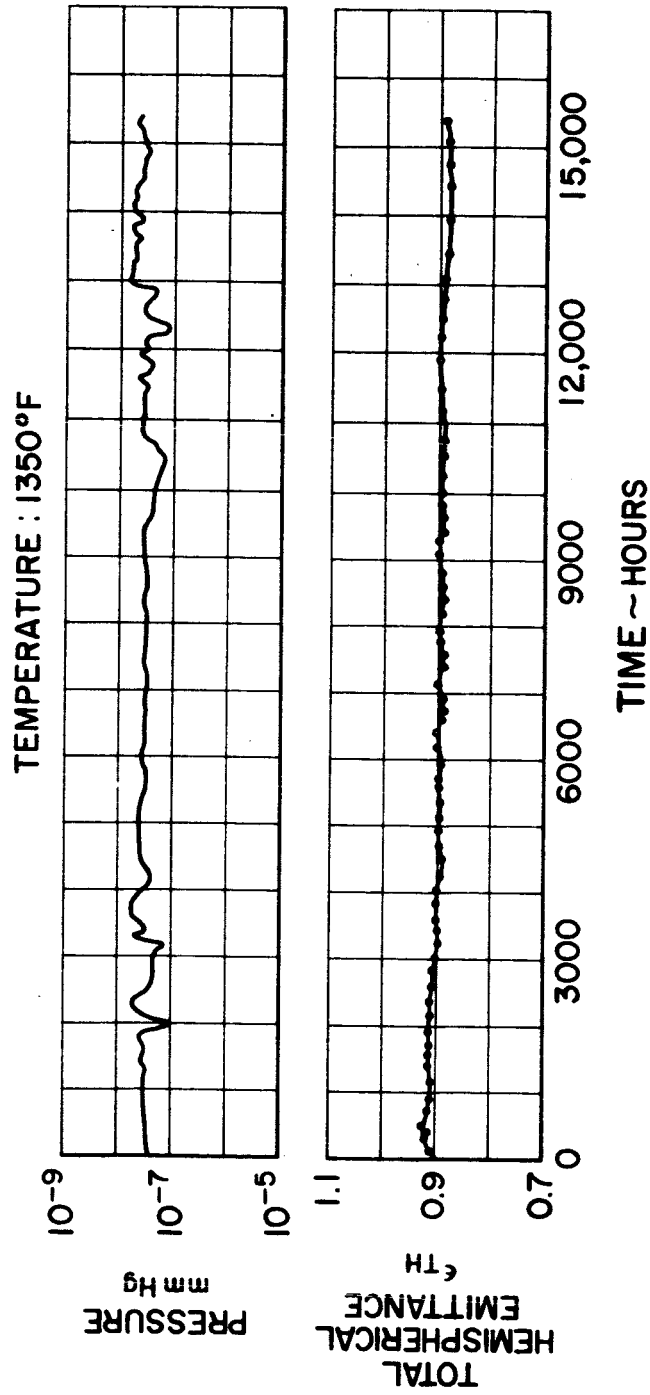
Figure 31 Pressure and Total Hemispherical Emittance for Long-Term Endurance Test of Calcium-Titanate-Coated AISI-310 Stainless Steel

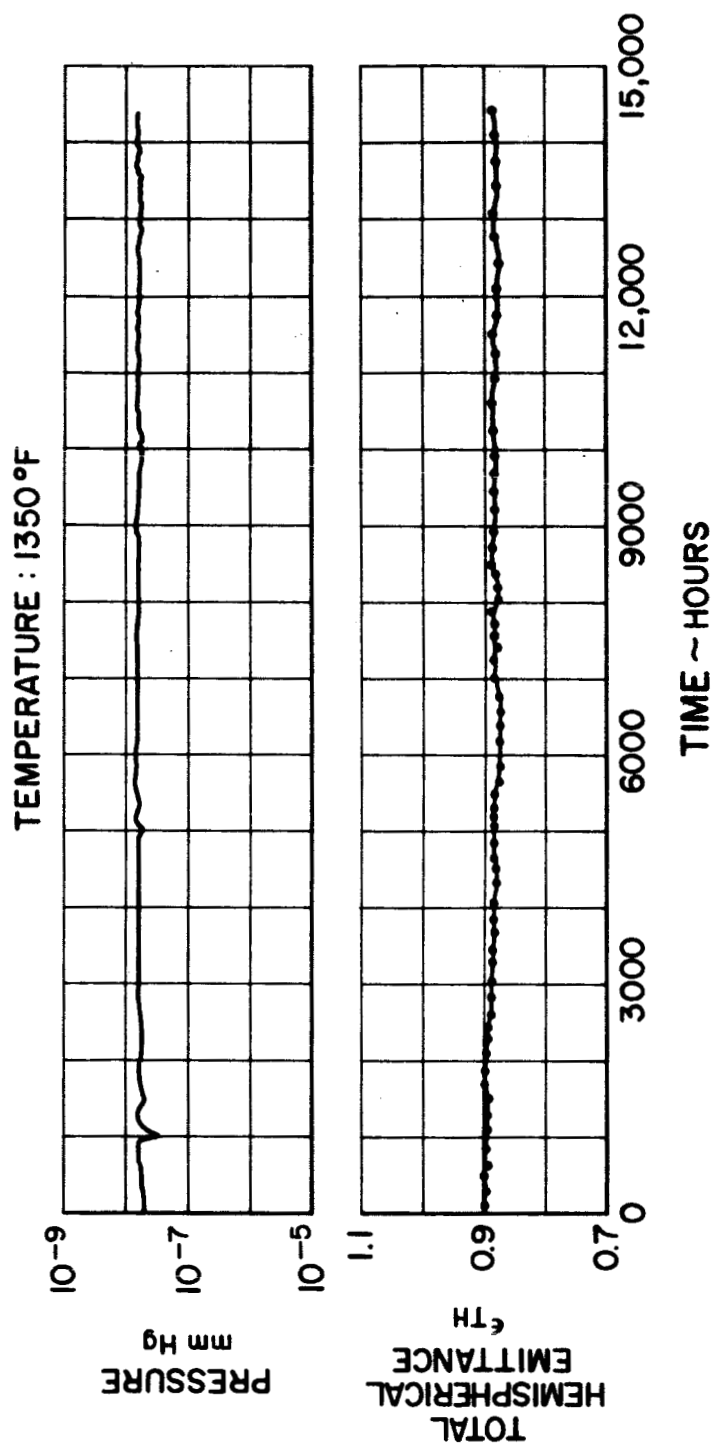
Figure 32 Pressure and Total Hemispherical Emittance for Long-Term Endurance Test of Iron-Titanate-Coated AISI-310 Stainless Steel
